# Manhole Inspection Summary

Manhole # S43II\_006MH

Insp Date: **4/25/08 8:26 AM**

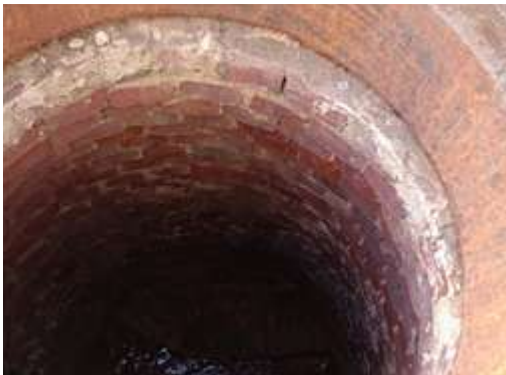
Defect 1

Infiltration: ☐ None ☒ **Joint** ☐ Cracks ☐ Mortar ☐ Roots ☒ **Wall**

Infiltration

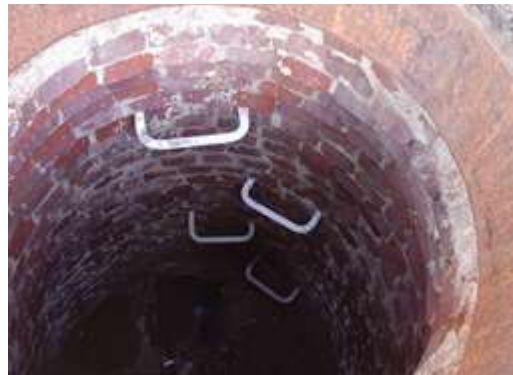
Defect 2

Frame Leaks

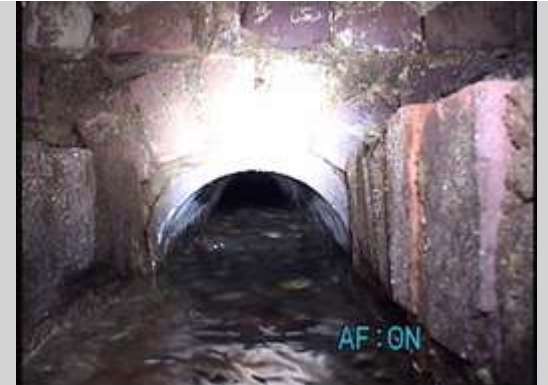
12 O'Clock Outflow

Pipe Height: **8.4** (in.) Rod and Bar (Angled)  
Pipe Material: **Clay** ☐ Pipe Lined  
Invert Depth: **9.05** (ft.) Flow Characteristics: **Fast**  
Deposits: ☒ None ☐ Mud ☐ Sludge ☐ Debris ☐ Grease  
Silt Depth: (in.) Deposits Extent:  
Infiltration: **None** Pipe Seal Cond: **Sound**

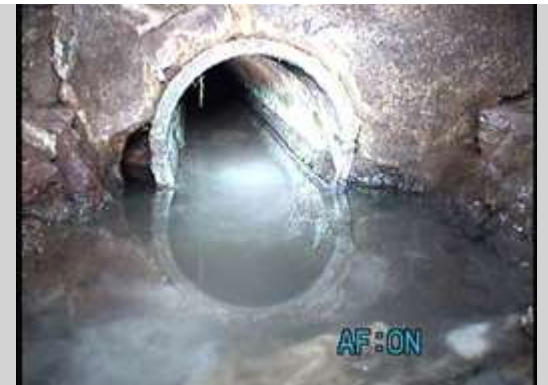
5 O'Clock Inflow

Pipe Height: **8.4** (in.) Rod and Bar (Angled)  
Pipe Material: **Clay** ☐ Pipe Lined  
Invert Depth: **8.75** (ft.) Flow Characteristics: **Slow**  
Deposits: ☒ None ☐ Mud ☐ Sludge ☐ Debris ☐ Grease  
Silt Depth: (in.) Deposits Extent:  
Infiltration: **None** Pipe Seal Cond: **Sound**

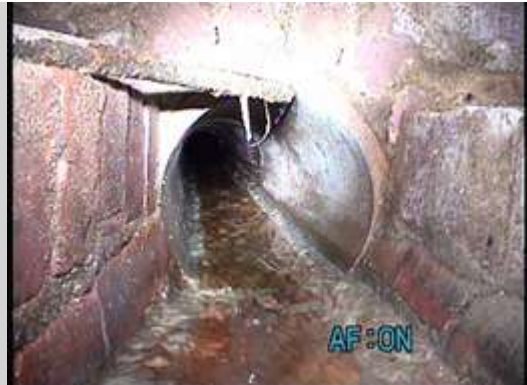
7 O'Clock Inflow

Pipe Height: **8.4** (in.) Rod and Bar (Angled)

Infiltration: **None**

Pipe Seal Cond: **Sound**
